COMPREHENSIVE MANAGEMENT PLAN for LAKE AGAWAM

Nelson, Pope & Voorhis, LLC
572 Walt Whitman Road
Melville, New York 11747
(631) 427-5665

June 2009

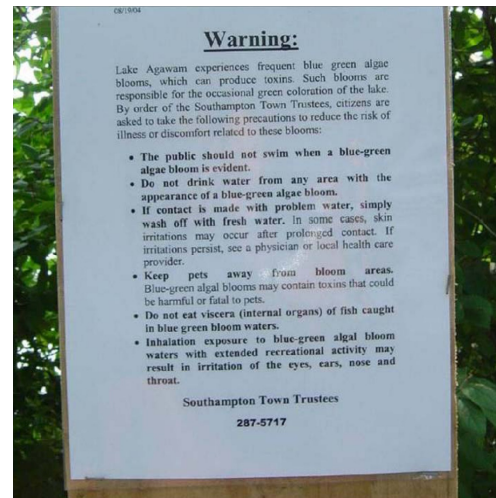
Photo: Chris Gobler, MSRC

As toxic blue green algae blooms are associated with stagnant, eutrophic waters, the following two approaches should be tested as methods for reducing the occurrence and risk of toxic cyanobacteria blooms in afflicted lake systems (**Gobler, 2007**):

1. Install water circulators to push surface dwelling cyanobacteria to the bottom of the lake, potentially preventing bloom occurrence; and
2. Target the reduction of primary sources of nutrients into Lake Ronkonkoma in conjunction with monitoring to assess the relation of nutrient loads on algal blooms.
